TECHNICAL REPORT NO. 11738

INFRARED NON-DESTRUCTIVE
ANALYSIS OF SOLID RUBBER
ROAD WHEELS

FEBRUARY 1973

U.S. ARMY TANK AUTOMOTIVE COMMAND Warren, Michigan

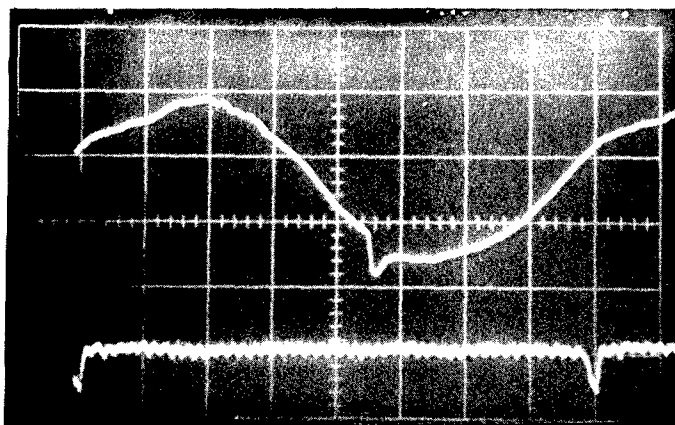
Test Wheel # 11
Right Sidewall

Gross Unbalance (out of round)

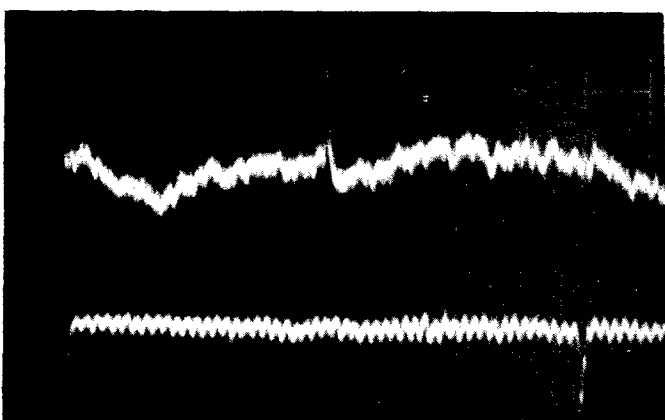
Test Wheel # 13
Tread

Tread Cut at 180°

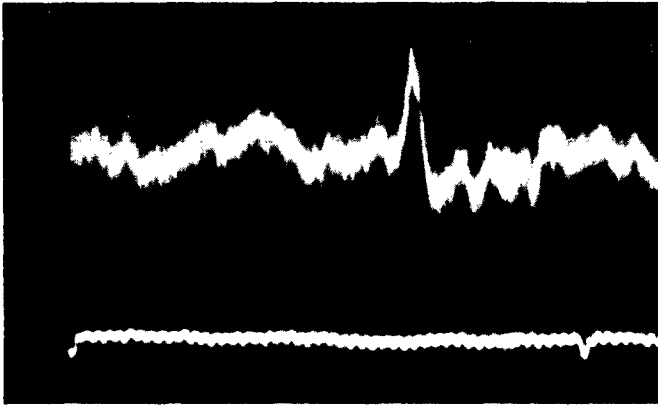
Test Wheel # 12
Right Sidewall

Sidewall Cut at 240°

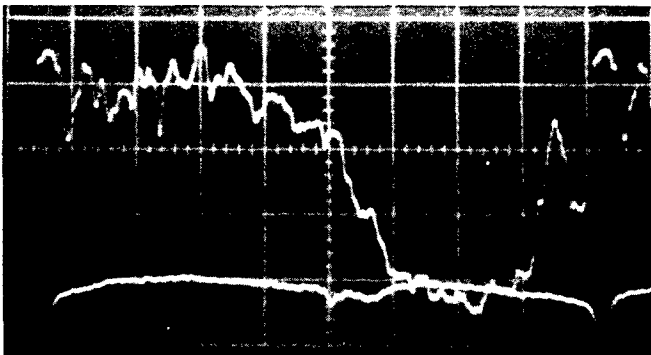
Test Wheel # 19
Right Sidewall

Gross Unbond, 220° to 310° , 15 Square Inches Area

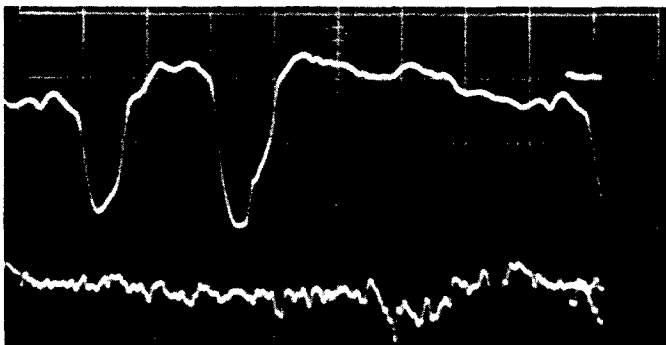
Test Wheel # 5

Minor Unbonds at 60° and 150° , 5 Square Inches
Area Each Unbond

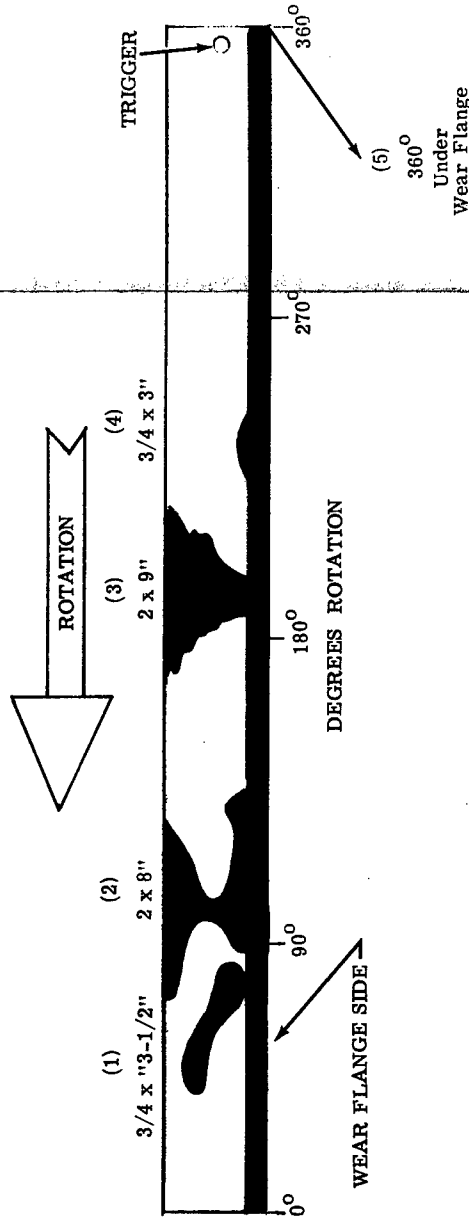
Figure 10 - Stripped Rubber Tread Interface

Description of Defects: Separated Completely Over Wear Flange

- (1) Unbond
- (2) Erosion
- (3) Unbond
- (4) Unbond
- (5) Unbond Along 300° Wear Flange

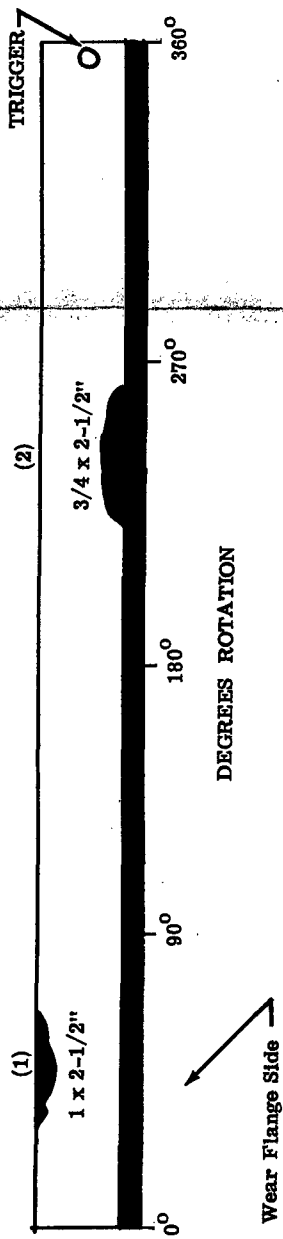
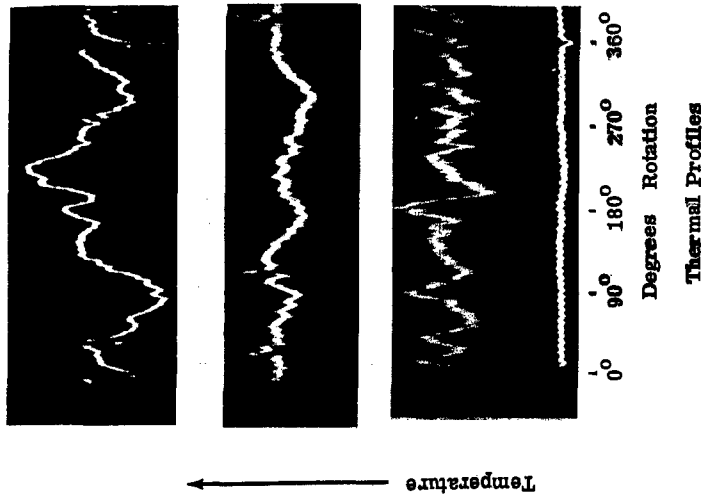
Figure 13 - Stripped Rubber Tread Interface

Description of Defects:
 Unbond Along Length of Wear Flange
 (1) Unbond
 (2) Unbond

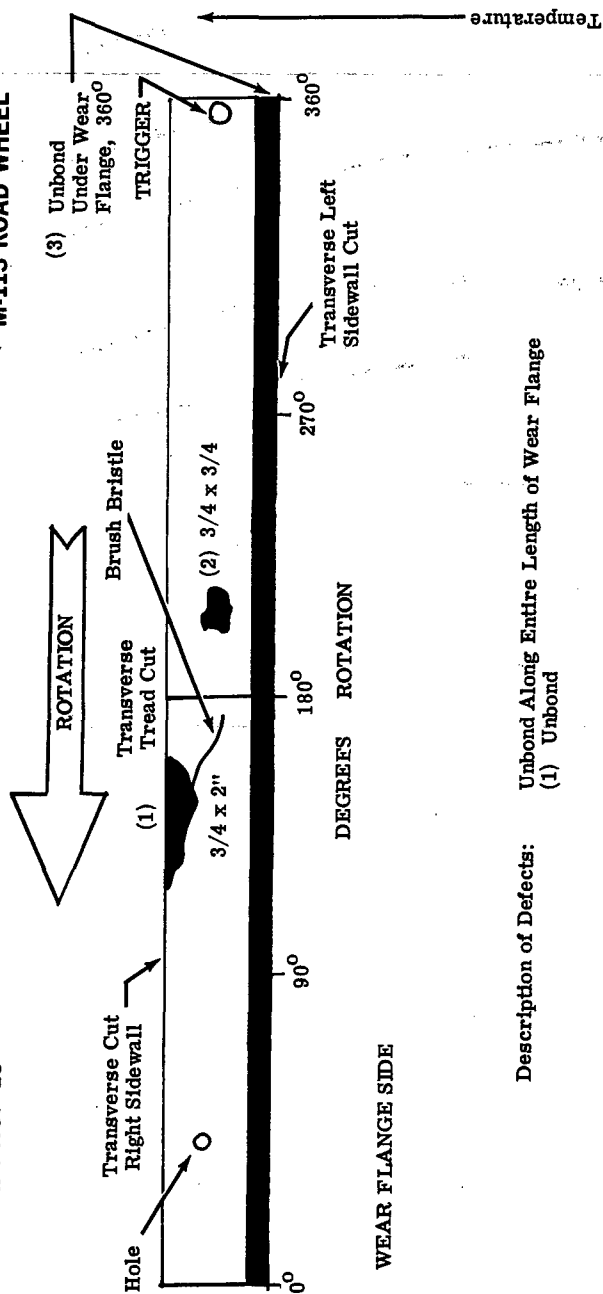
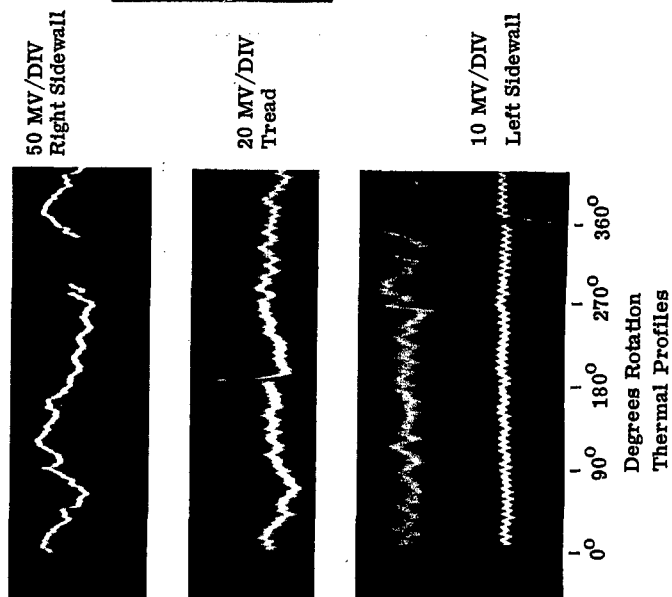
Figure 14 - Stripped Rubber Tread Interface

Description of Defects: Unbond Along Entire Length of Wear Flange (1) Unbond

Simulated Defects: Needle Hole - Acetone Injected At Interface (45°)
Transverse Left Sidewall Cut (90°)
Transverse Tread Cut (180°)
Transverse Right Sidewall Cut (270°)

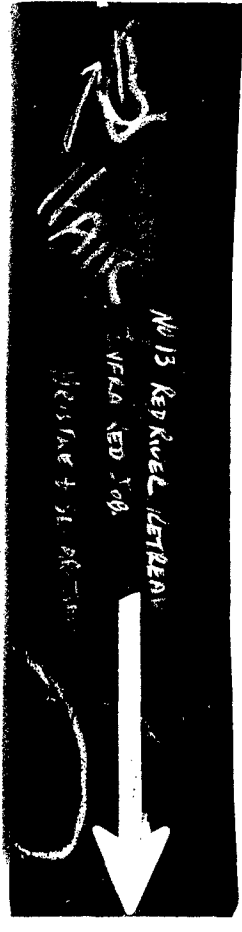
Brush Bristle (Hair) at 175°

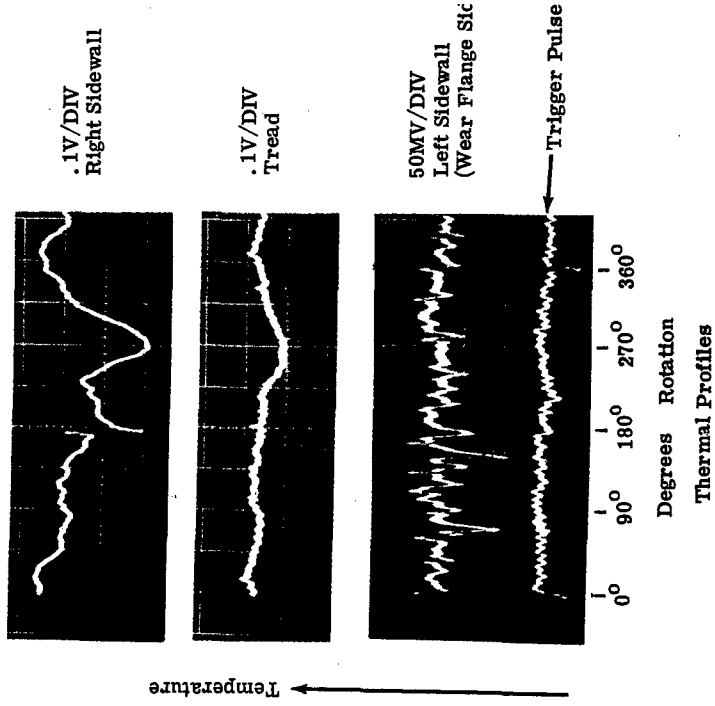
Figure 15 - Stripped Rubber Tread Interface

Description of Defects: All Defects Less Than 1 Sq. In.

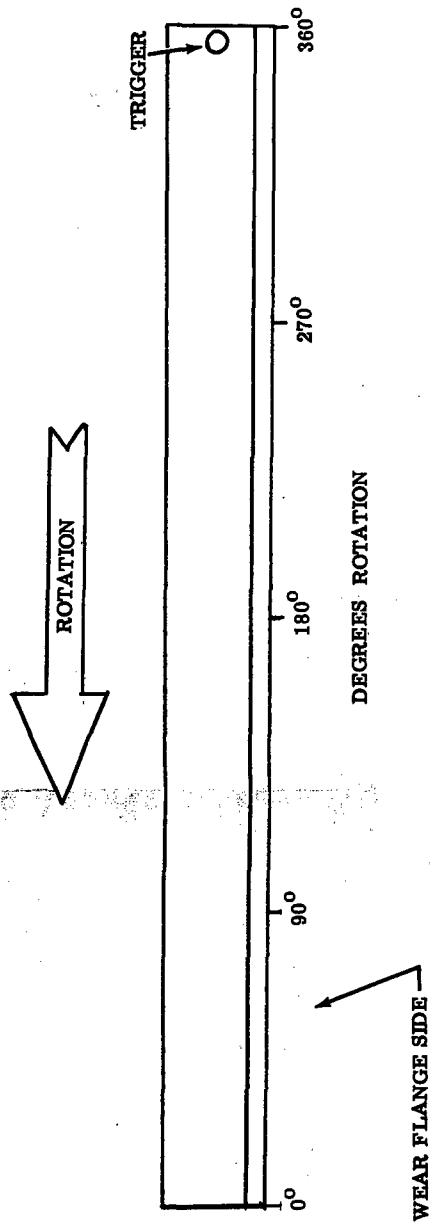
Figure 16

NO DEFECTS Wheel Out of Round (Gross Unbalance)

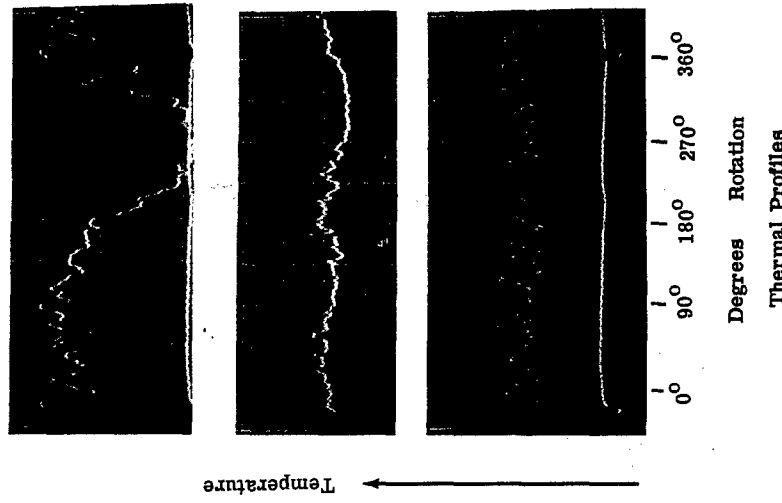
Figure 17 - Stripped Rubber Tread Interface

- (1) Unbond
- (2) Unbond
- (3) Track Guide Damage
- (4) Unbond
- (5) Unbond
- (6) Unbond

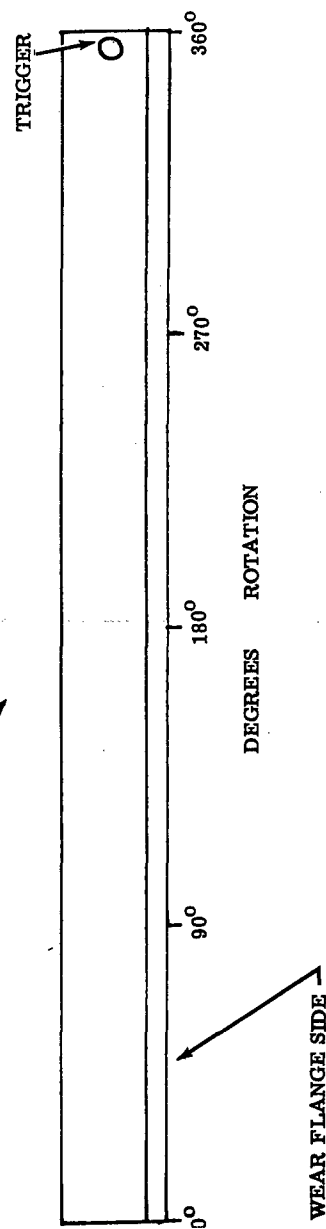
Figure 18 - Stripped Rubber Tread Interface

No Defects Developed During Drum Test

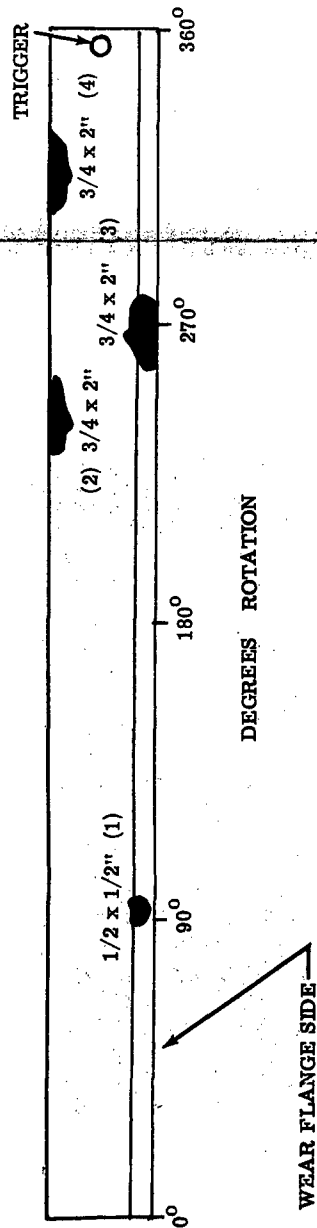
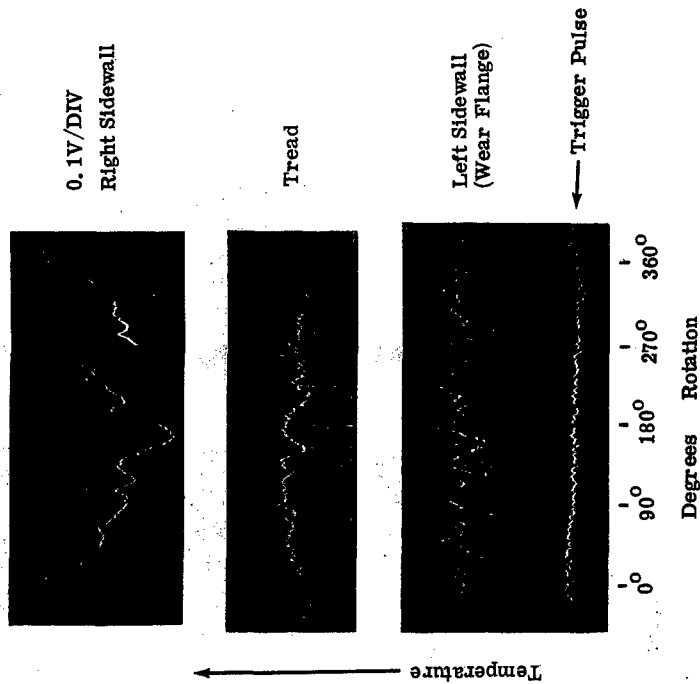
Description of Defects: (1) Erosion (3) Erosion
(2) Unbond (4) Unbond

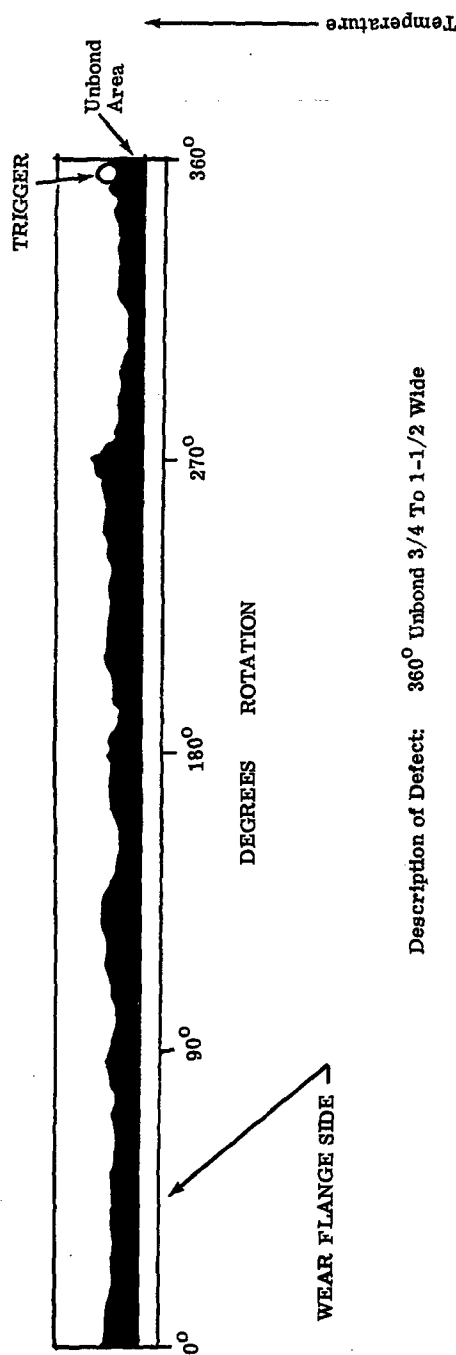
Figure 20 - Stripped Rubber Tread Interface

Description of Defect: 360° Unbond 3/4 To 1-1/2 Wide
